Northeast Fisheries Science Center Reference Document 07-07

# Evaluation of a Modified Scallop Dredge's Ability to Reduce the Likelihood of Damage to Loggerhead Sea Turtle Carcasses

April 2007

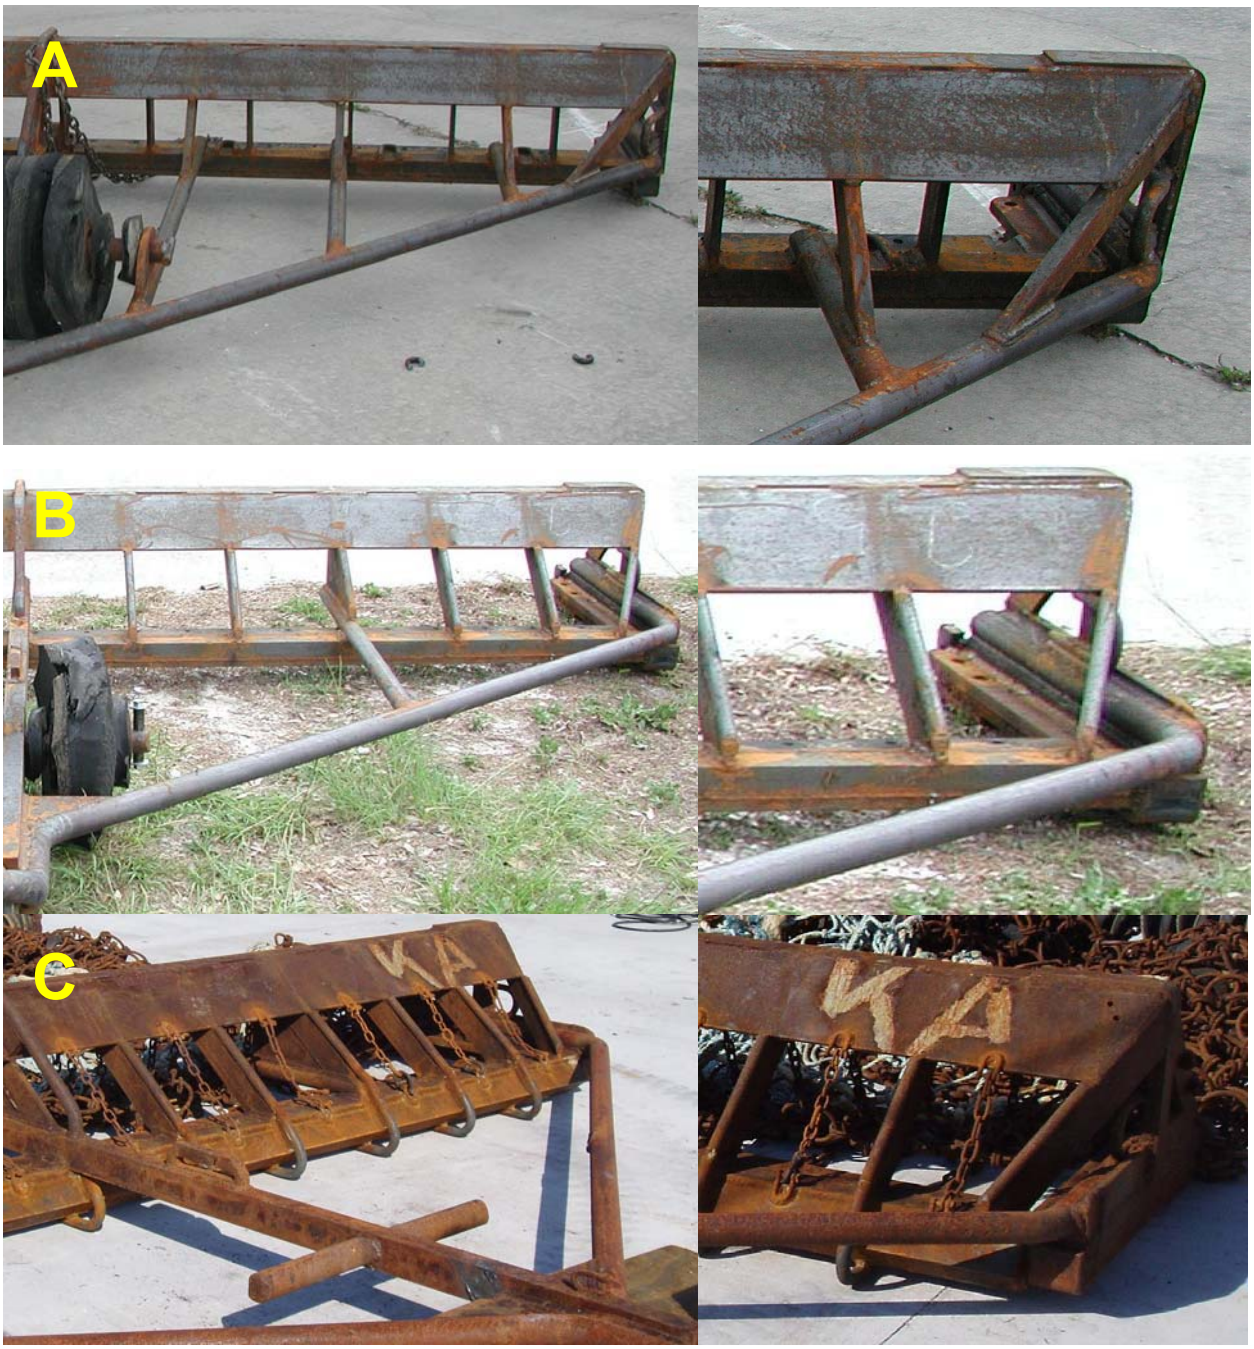
Figure 1. New Bedford style scallop dredge (A) and modified scallop dredge used in 2005 study (B). Modified dredge has cutting bar forward of traditional dredge resulting in a "ramp". (C) Dredge used in 2006 modified by reducing the vertical flat surface of the cutting bar and removal of all bale support bars.

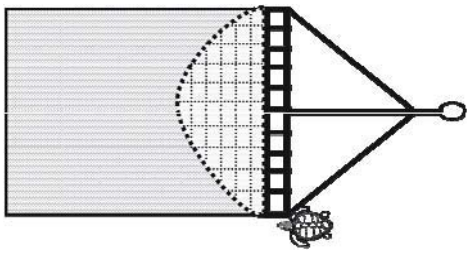
**Tow #3 Turtle carcass #1 deployed ahead of the dredge**
Scope: 5.1:1
Cable: 150 ft
Depth: 28 ft
Speed: 3.0 kts
Carcass Placement and Orientation:

| Tow | Disposition | Turtle | Assess | Observed damage | Score of severity |
|---|---|---|---|---|---|
| 3 | Deflected off side | 1 | Yes | minor abrasions - front flippers | 1 |

Comments: The carcass was placed in front of the starboard edge of the dredge and did not go under the bale. The carcass deflected off the starboard shoe away from the dredge. Divers deploying the carcass had trouble locating the oncoming dredge due to the length of cable deployed. Also, the captain had trouble making adjustments due to the amount of cable deployed.

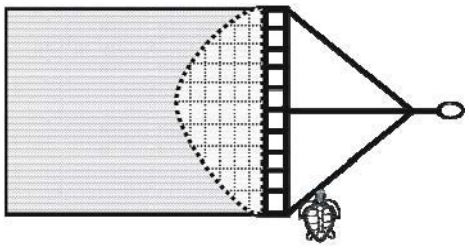
**Tow #4 Turtle carcass #1 deployed ahead of the dredge**
Scope: 5:1
Cable: 125 ft
Depth: 25 ft
Speed: 3.0 kts
Carcass Placement and Orientation:

| Tow | Disposition | Turtle | Assess | Observed damage | Score of severity |
|---|---|---|---|---|---|
| 4 | Up and over side | 1 | No | no additional damage | 1 |

Comments: Cable length was shortened to 125 ft to provide the captain with better maneuverability and allowed divers to adjust to dredge more effectively. The carcass was placed in front of the starboard edge of the dredge and did not go under the bale. The carcass was held on the outer edge of the bale for approximately 30 seconds before it came off and went up and over the dredge. The amount of clearance between the bale and the bottom at this scope did not allow the turtle carcass to pass under the bale. Because of difficulties experienced with the 5:1 ratio, it was agreed that subsequent tows should match the 2005 testing scenario with a 3:1 ratio at 3.0 knots. In 2005, scallop dredge fishermen and industry representatives that attended testing determined that this ratio speed combination provided a dredge attitude that best matched that observed on commercial dredges during normal fishing conditions. The 3:1 ratio also provided better maneuverability, diver response time, and enough clearance to place carcasses under the bale, which was a more conservative testing approach.

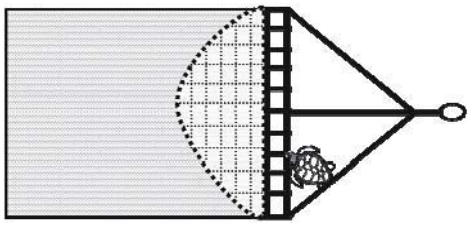
**Tow #6 Turtle carcass #2 deployed ahead of the dredge**
Scope: 3:1
Cable: 90 ft
Depth: 30 ft
Speed: 3.0 kts
Carcass Placement and Orientation:

| Tow | Disposition | Turtle | Assess | Observed damage | Score of severity |
|---|---|---|---|---|---|
| 6 | Bale held turtle from going over | 2 | Yes | small crack - marginal; abrasions - flipper, carapace, marginals | 1 |

Comments: The carcass was placed under the starboard side of the dredge bale and made contact with the cutting bar in the center of the starboard side of the dredge approximately 3 feet from the edge (Figure 2A). The carcass was facing the dredge and turned slightly to the right, with the left front flipper trapped under the cutting bar by water pressure and the posterior edge of the shell held down by the bale (Figure 2B). The carcass was held in this position for approximately 4 minutes before divers removed it. The front flipper was trapped under the cutting bar and against a vertical piece of round stock that was added to the front edge of the cutting bar and pressure plate (Figure 2C and D).

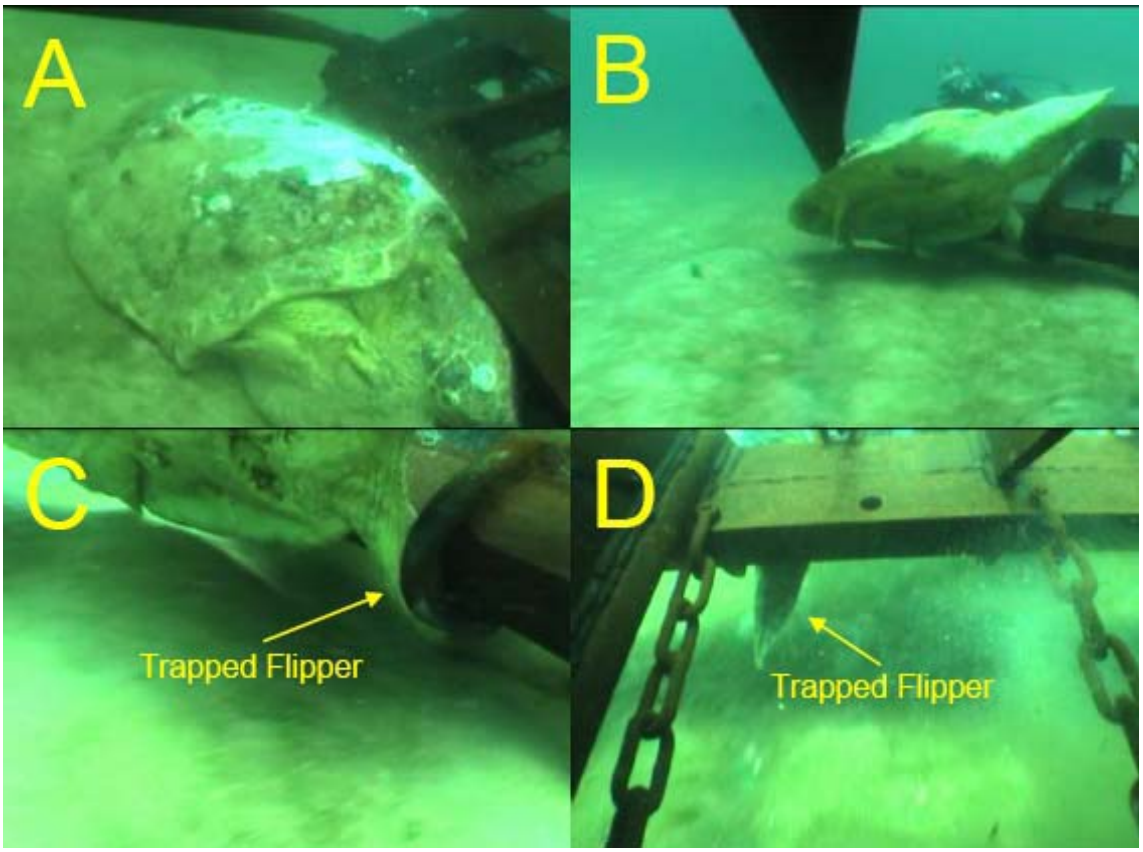
Figure 2. Photos taken from video collected during tow #6 of modified scallop dredge testing June 20, 2006. (A) Initial impact with the dredge; (B) carcass caught under bale; (C) flipper under cutting bar and against round stock modification; (D) rear view of flipper.

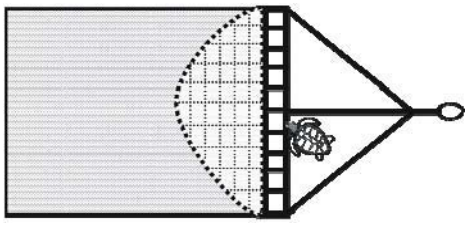
**Tow #7 Turtle carcass #2 deployed ahead of the dredge**
Scope: 3:1
Cable: 90 ft
Depth: 28 ft
Speed: 3.0 kts
Carcass Placement and Orientation:

| Tow | Disposition | Turtle | Assess | Observed damage | Score of severity |
|---|---|---|---|---|---|
| 7 | Went over | 2 | No | part of carapace loose/cracked; abrasions - head, flipper | 2 |

Comments: The carcass was placed under the starboard side of the dredge bale and made contact with the cutting bar just to the starboard side of the center bar approximately 6 feet from the edge of the frame (Figure 3A). The carcass was facing the dredge and turned slightly to the right with the front left flipper and head making initial contact. The carcass then flipped up onto the front of the dredge (Figure 3B and C). The right front flipper was momentarily trapped under the cutting bar before releasing and allowing the carcass to flip up and over the dredge (Figure 3C and D).

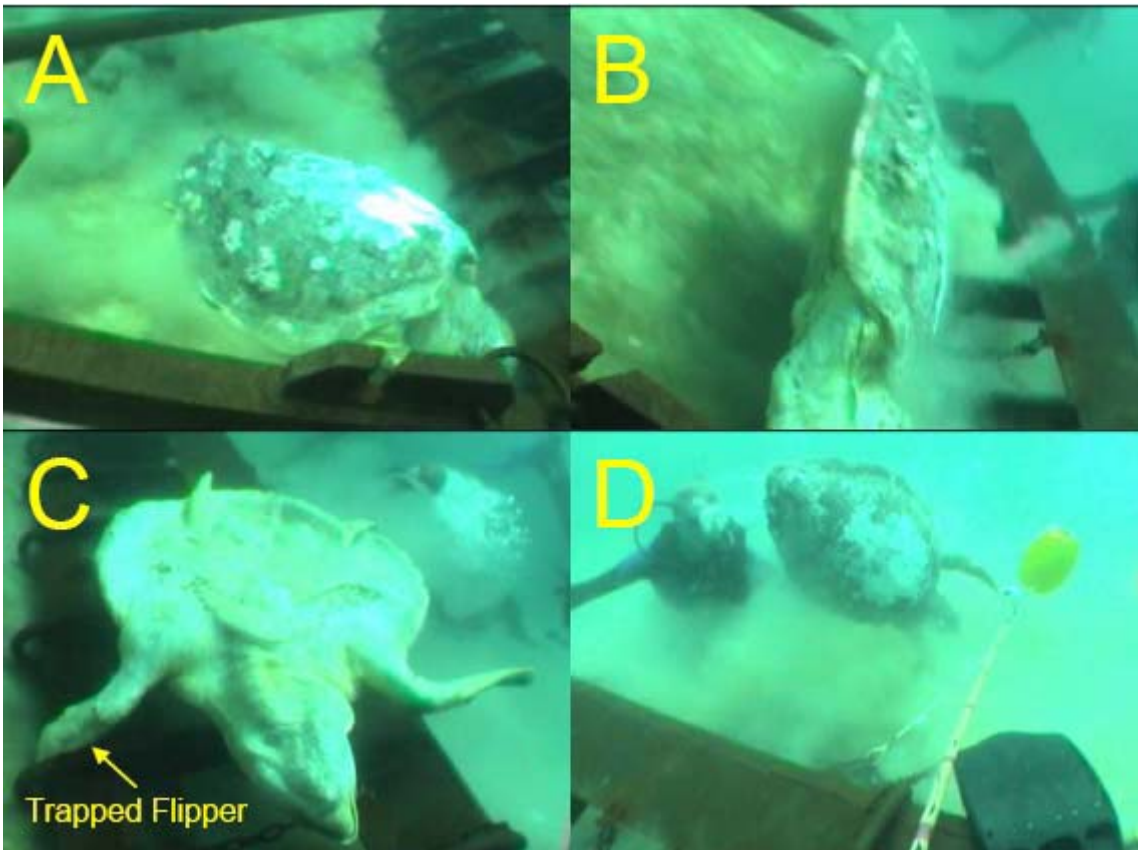
Figure 3. Photos taken from video collected during tow #7 of modified scallop dredge testing June 20, 2006. (A) Initial impact with the dredge; (B) carcass beginning to flip up; (C) carcass flipping onto dredge with flipper momentarily trapped; (D) carcass going over dredge.

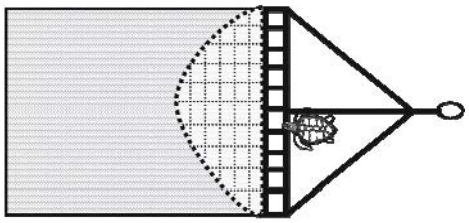
**Tow #8 Turtle carcass #3 deployed ahead of the dredge**
Scope: 3:1
Cable: 90 ft
Depth: 27 ft
Speed: 3.0 kts
Carcass Placement and Orientation:

| Tow | Disposition | Turtle | Assess | Observed damage | Score of severity |
|---|---|---|---|---|---|
| 8 | Went over | 3 | Yes | abrasions - head, carapace, marginals | 1 |

Comments: The carcass was placed under the starboard side of the dredge bale and made contact with the cutting bar just to the starboard side of the center bar approximately 6 feet from the edge of the frame (Figure 4A). The carcass was facing the dredge and made contact head first. The carcasses stayed in position for a few seconds and proceeded to flip up and over the pressure plate where it was recovered by divers (Figure 4B).

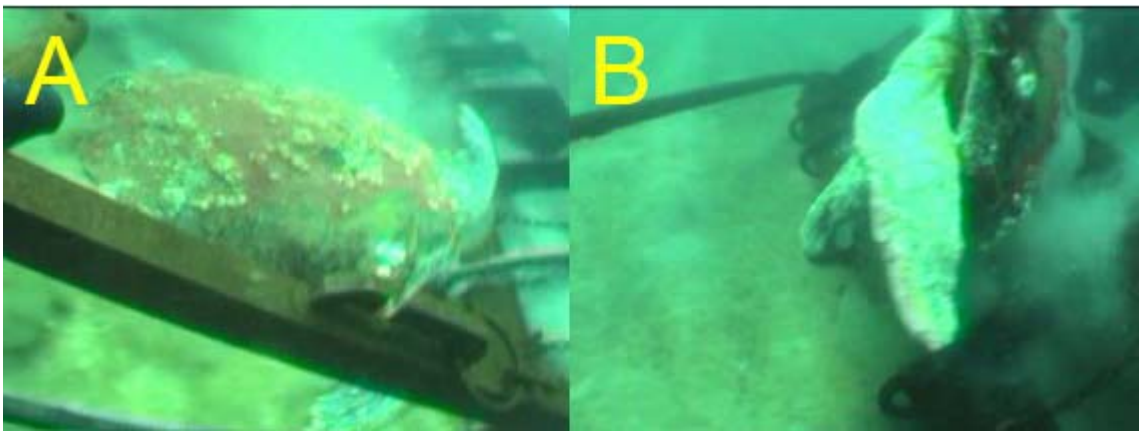
Figure 4. Photos taken from video collected during tow #8 of modified scallop dredge testing June 20, 2006. (A) Initial impact with the dredge; (B) carcass flipping up and over the dredge.

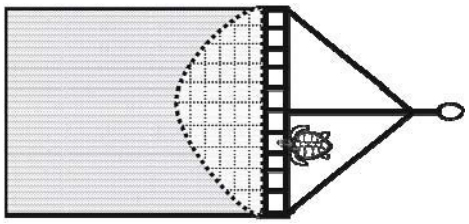
**Tow #10 Turtle carcass #4 deployed ahead of the dredge**
Scope: 3:1
Cable: 90 ft
Depth: 34 ft
Speed: 3.0 kts
Carcass Placement and Orientation:

| Tow | Disposition | Turtle | Assess | Observed damage | Score of severity |
|---|---|---|---|---|---|
| 10 | Went over | 4 | Yes | abrasions - flippers, head, jaw, carapace, marginals | 1 |

Comments: The carcass was placed under the starboard side of the dredge bale and made contact with the cutting bar near the middle of the starboard side of the dredge approximately 4 feet from the edge of the frame (Figure 5A). The carcass was facing the dredge and made contact head first. The carcass slid up the face of the dredge immediately after impact and proceeded to go over the pressure plate (Figure 5B).

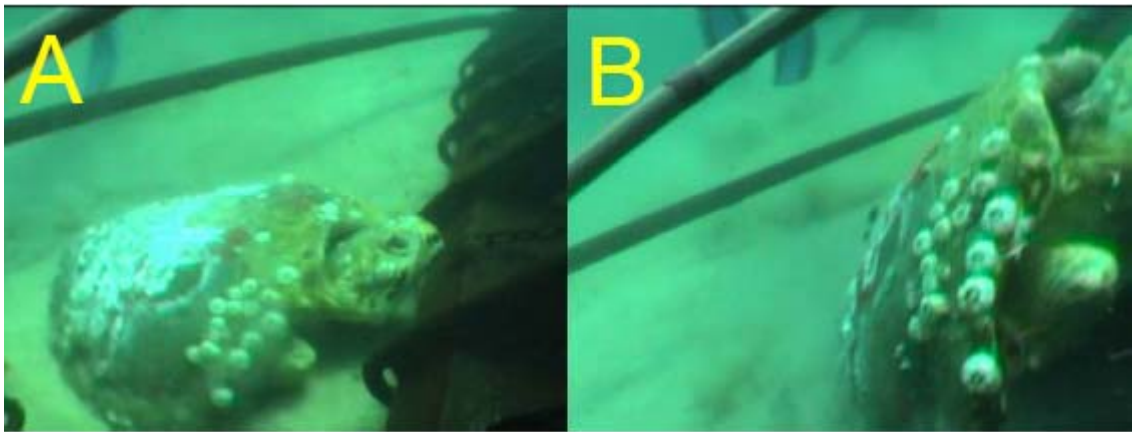
Figure 5. Photos taken from video collected during tow #10 of modified scallop dredge testing June 21, 2006. (A) Initial impact with the dredge; (B) carcass sliding up and over the dredge.

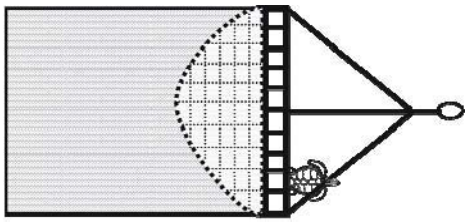
**Tow #11 Turtle carcass #3 deployed ahead of the dredge**
Scope: 3:1
Cable: 90 ft
Depth: 30 ft
Speed: 3.0 kts
Carcass Placement and Orientation:

| Tow | Disposition | Turtle | Assess | Observed damage | Score of severity |
|---|---|---|---|---|---|
| 11 | Bale held turtle from going over | 3 | No | posterior plastron/carapace broken/missing; abrasions - carapace, flippers | 3 |

Comments: The carcass was placed under the starboard side of the dredge bale and made contact with the cutting bar near the edge of the starboard side of the dredge approximately 3 feet from the edge of the frame (Figure 6A). The carcass encountered the dredge tail first. The posterior edge of the carapace was caught under the cutting bar while the anterior portion of the carapace was held down by the dredge bale, which prevented the carcass from flipping up and over the dredge frame (Figure 6B).

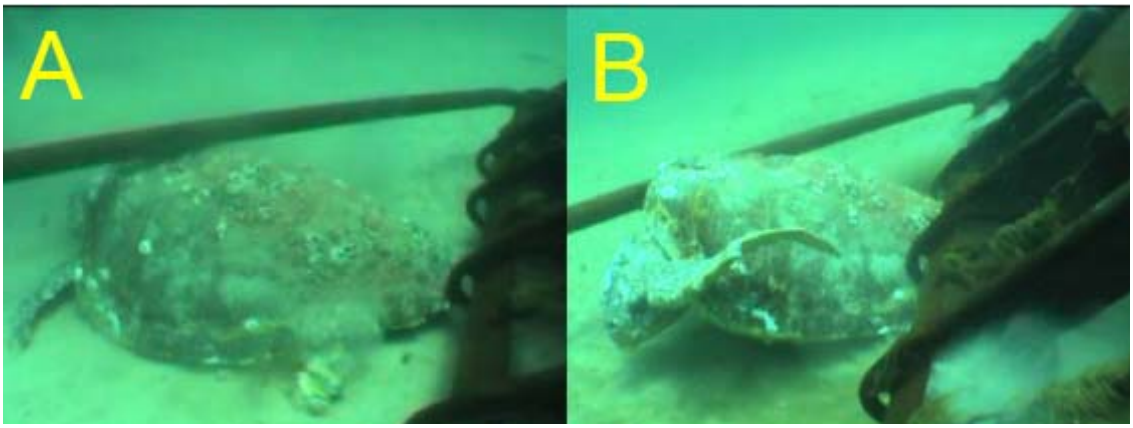
Figure 6. Photos taken from video collected during tow #11 of modified scallop dredge testing June 21, 2006. (A) Initial impact with the dredge; (B) carcass caught under bale and cutting bar.

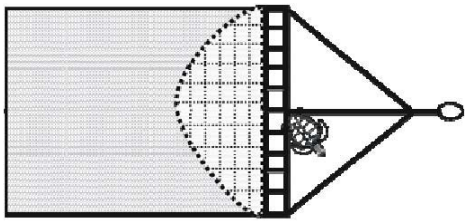
**Tow #12 Turtle carcass #4 deployed ahead of the dredge**
Scope: 3:1
Cable: 90 ft
Depth: 29 ft
Speed: 3.0 kts
Carcass Placement and Orientation:

| Tow | Disposition | Turtle | Assess | Observed damage | Score of severity |
|---|---|---|---|---|---|
| 12 | Went over | 4 | No | no additional damage | 1 |

Comments: The carcass was placed under the starboard side of the dredge bale and made contact with the cutting bar near the center of the dredge just on the starboard side of the center brace bar approximately 6 feet from the edge of the frame (Figure 7A). The carcass encountered the dredge tail first and was angled to the right. Upon impact the carcass slid up the face of the dredge and stalled on the pressure plate (Figure 7B and C). The carcass's front left flipper was trapped under the cutting bar and against a vertical piece of round stock (Figure 7D). The carcass was held in this position for approximately one minute before it moved the rest of the way over the dredge.

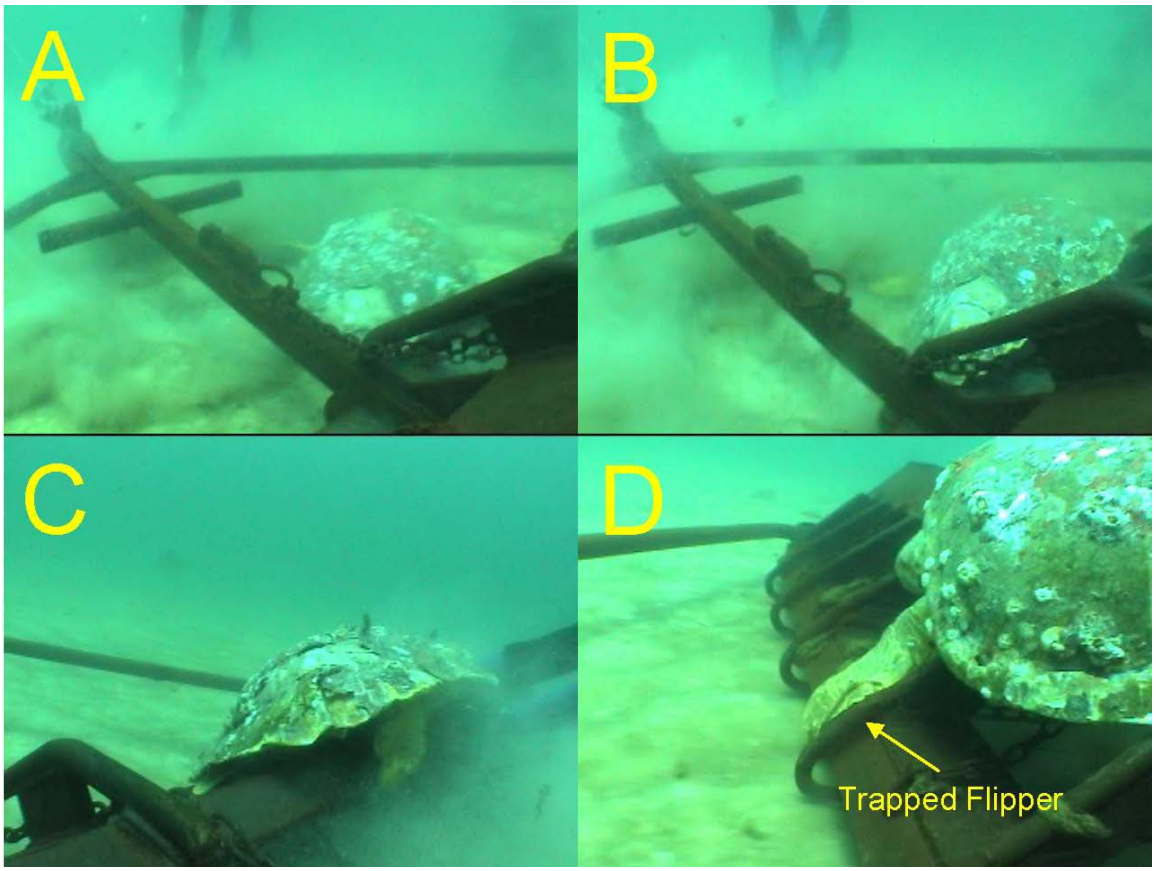
Figure 7. Photos taken from video collected during tow #12 of modified scallop dredge testing June 21, 2006. (A) Initial impact with the dredge; (B) carcass sliding up face of the dredge; (C) carcass stopping on the pressure plate; (D) flipper which may have temporarily held carcass in place.

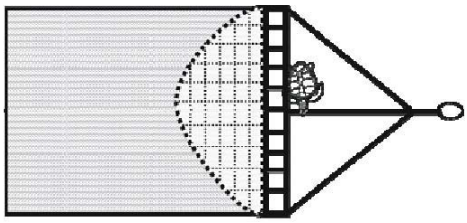
**Tow #13 Turtle carcass #4 deployed ahead of the dredge**
Scope: 3:1
Cable: 90 ft
Depth: 30 ft
Speed: 3.0 kts
Carcass Placement and Orientation:

| Tow | Disposition | Turtle | Assess | Observed damage | Score of severity |
|---|---|---|---|---|---|
| 13 | Went over | 4 | No | right side carapace bone broken, almost off; crack - posterior carapace | 3 |

Comments: The carcass was placed under the port side of the dredge bale and made contact with the cutting bar near the center of the dredge just on the port side of the center brace bar approximately 5 feet from the edge of the frame (Figure 8A). The carcass was facing to the right and encountered the dredge along its entire right side. Upon impact the carcass flipped up and over the dredge (Figure 8B).

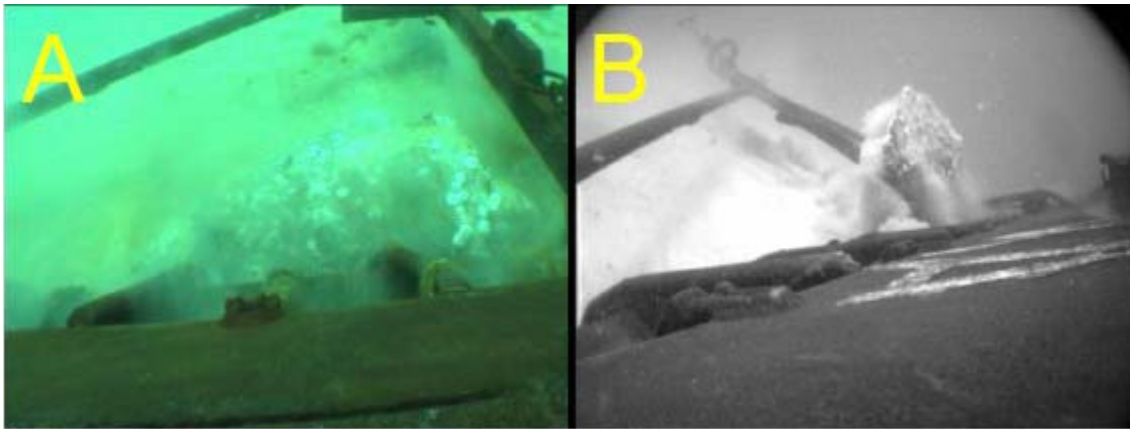
Figure 8. Photos taken from video collected during tow #13 of modified scallop dredge testing June 21, 2006. (A) Initial impact with the dredge; (B) carcass flipping up and over the dredge.

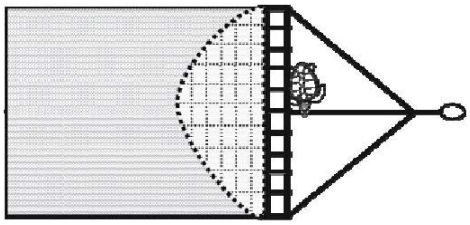
**Tow #14 Turtle carcass #5 deployed ahead of the dredge**
Scope: 3:1
Cable: 90 ft
Depth: 30 ft
Speed: 3.0 kts
Carcass Placement and Orientation:

| Tow | Disposition | Turtle | Assess | Observed damage | Score of severity |
|---|---|---|---|---|---|
| 14 | Went over / trapped[1] | 5 | Yes | no additional damage | 1 |

Comments: The carcass was large and bloated and required the addition of thirty pounds of weight to sink. The carcass was placed under the port side of the dredge bale and made contact with the cutting bar just to the port side of the center brace bar approximately 5 feet from the edge of the frame (Figure 9A). The carcass was facing to the right and encountered the dredge along its entire right side. Upon impact the carcass slid up the face of the dredge and stopped (Figure 9B). The attached weights may have hung on the face of the dredge preventing it from sliding completely over the dredge. In addition, both front flippers were under the cutting bar which may have also prevented the carcass from sliding any further up the face of the dredge (Figure 9B).

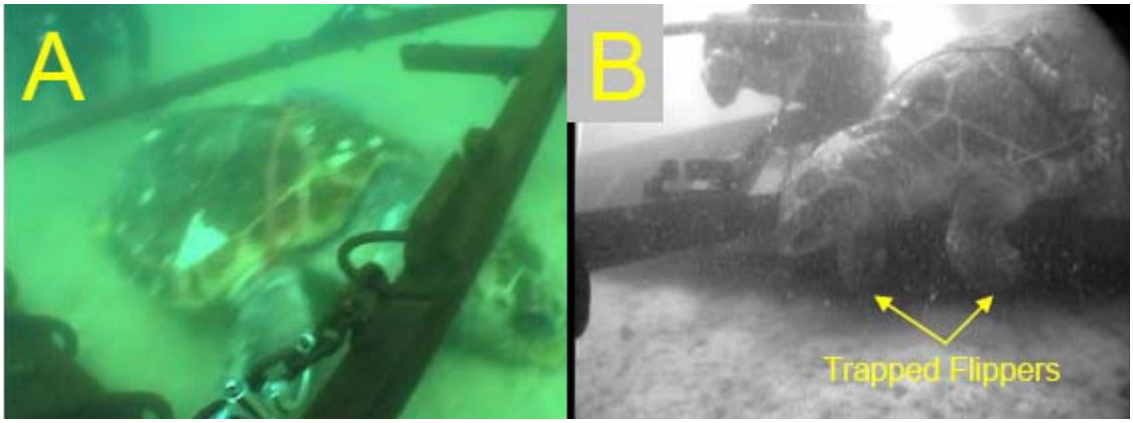
Figure 9. Photos taken from video collected during tow #14 of modified scallop dredge testing June 22, 2006. (A) Initial impact with the dredge; (B) carcass sliding up the face of the dredge.

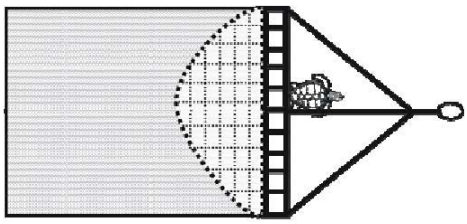
**Tow #15 Turtle carcass #5 deployed ahead of the dredge**
Scope: 3:1
Cable: 90 ft
Depth: 32 ft
Speed: 3.0 kts
Carcass Placement and Orientation:

| Tow | Disposition | Turtle | Assess | Observed damage | Score of severity |
|---|---|---|---|---|---|
| 15 | Went over | 5 | No | no additional damage | 1 |

Comments: This was the same carcass used on the previous tow and required the addition of weights to sink. The carcass was placed under the port side of the dredge bale and made contact with the cutting bar on the port side of the center brace bar about 5 feet from the edge of the frame (Figure 10A). The carcass encountered the dredge tail first. Upon impact the carcass flipped up and over the face of the dredge (Figure 10B).

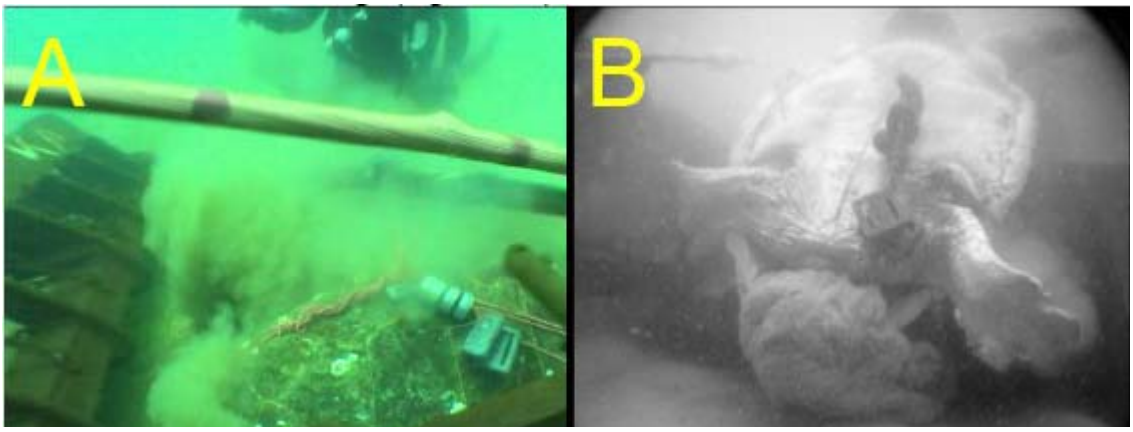
Figure 10. Photos taken from video collected during tow #15 of modified scallop dredge testing June 22, 2006. (A) Initial impact with the dredge; (B) carcass flipping up and over the dredge.

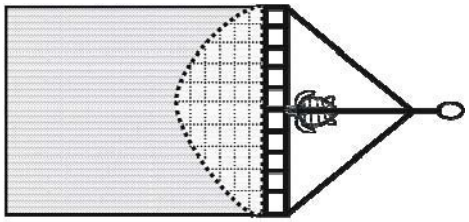
**Tow #16 Turtle carcass #2 deployed ahead of the dredge**
Scope: 3:1
Cable: 90 ft
Depth: 31 ft
Speed: 3.0 kts
Carcass Placement and Orientation:

| Tow | Disposition | Turtle | Assess | Observed damage | Score of severity |
|---|---|---|---|---|---|
| 16 | Bale held turtle from going over | 2 | No | anterior plastron ripped open, part missing; posterior marginals broken off, side marginals loose; abrasions - head, flippers, carapace | 3 |

Comments: The carcass was placed directly under the center brace bar (Figure 11A). The carcass encountered the dredge head first and was held under the center brace bar until divers removed it (Figure 11B).

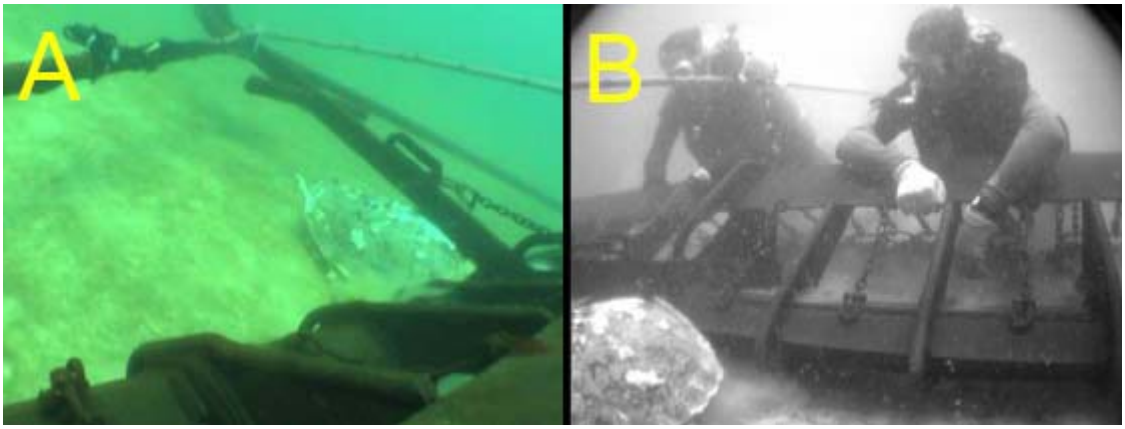
Figure 11. Photos taken from video collected during tow #16 of modified scallop dredge testing June 22, 2006. (A) Initial impact with the dredge; (B) divers preparing to remove carcass from under the center brace bar.

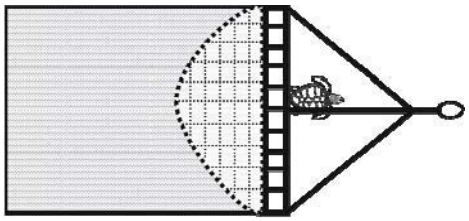
**Tow #17 Fiberglass Turtle Model #1 deployed ahead of the dredge**
Scope: 3:1
Cable: 90 ft
Depth: 30 ft
Speed: 3.0 kts
Plastic Turtle Placement and Orientation:

In addition to the twelve trials with carcasses, one trial (tow 17) used a fiberglass turtle. The fiberglass turtle became trapped under the bale by its rigid flippers (see Figure 12 in Appendix 1). Because of the rigidity of the appendages, it is difficult to infer very much from this interaction.

Comments: The model was placed under the port side of the dredge bale and made contact with the cutting bar near the center of the dredge just on the port side of the center brace bar 5 feet from the edge of the frame (Figure 12A and B). The model encountered the dredge tail first. Upon impact the model started to flip up but the head caught under a cross bar where wheels had been previously mounted on the center bar. This prevented the model from flipping up and over the dredge (Figure 12C). In addition, the right rear flipper was trapped under the cutting bar (Figure 12D).

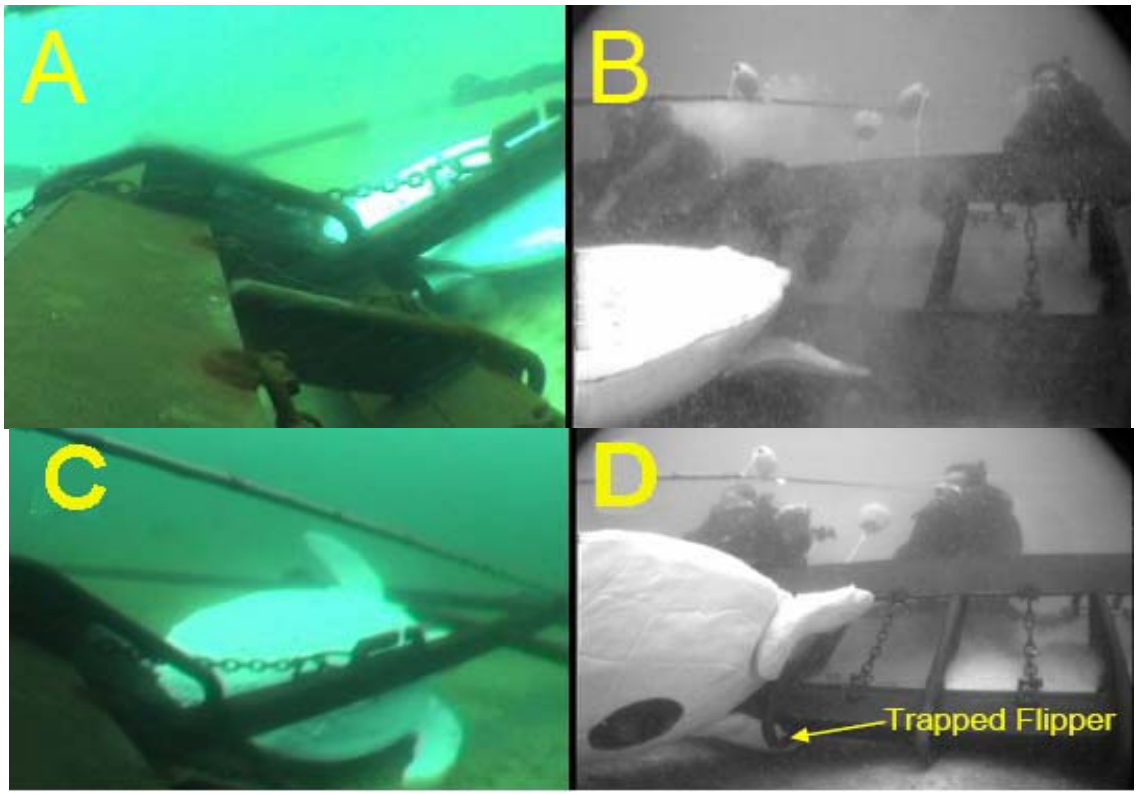
Figure 12. Photos taken from video collected during tow #17 of modified scallop dredge testing June 22, 2006. (A) Initial impact with the dredge; (B) initial impact with the dredge; (C) turtle model caught with head under crossbar (D) rear flipper of model shown under cutting bar.

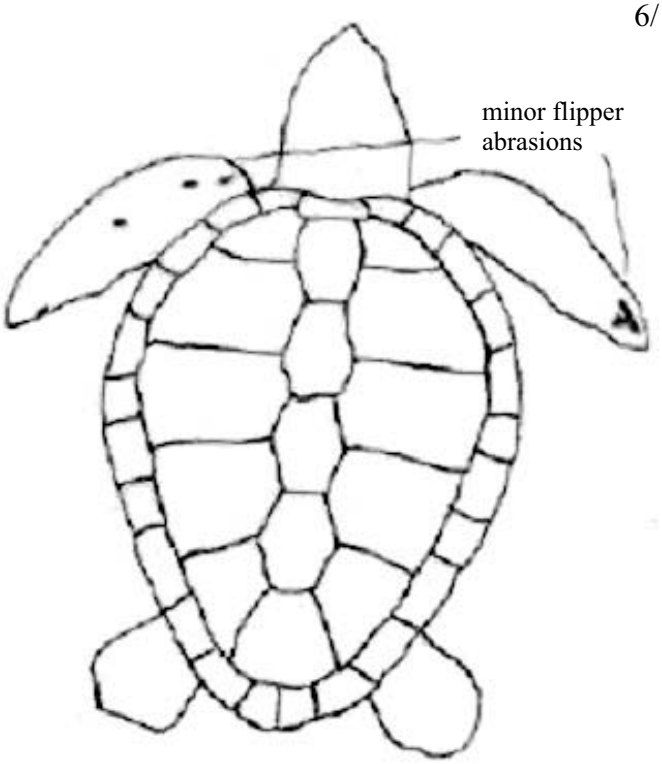
Turtle #1 – Post-test documentation 6/19/06

Tow #3
Turtle went around end of dredge, minimal impact. Carcass examined, no visible injuries, minor abrasions on front flippers.

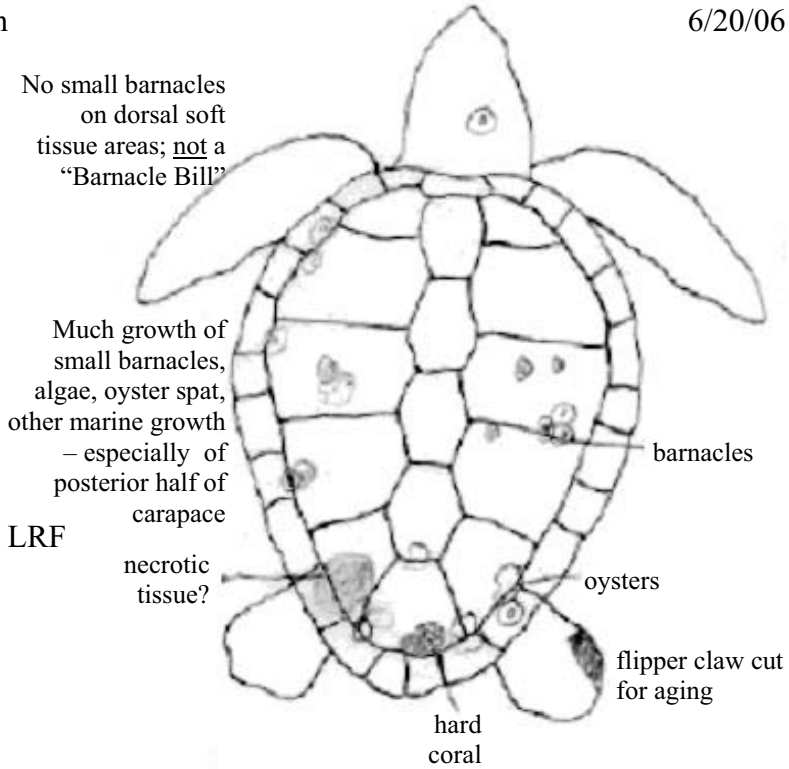
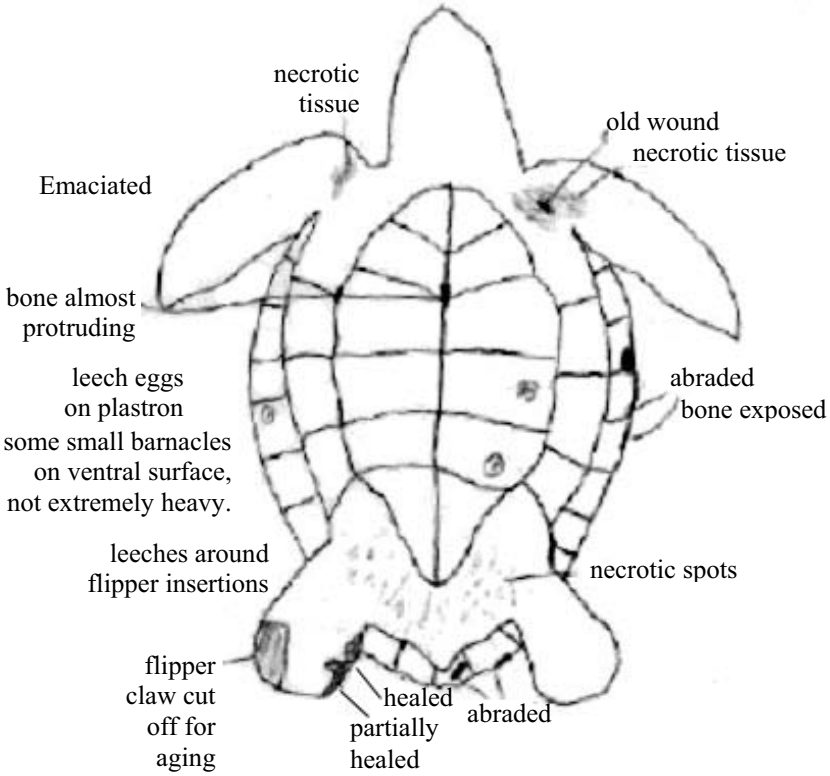
Turtle #2 Post-test documentation 6/20/06

Tow #6 (see diagrams):
Abrasions on L & R side marginals, both dorsal and ventral. Crack in bone in left side marginals, only visible ventral. Abraded to bone on RC #4.

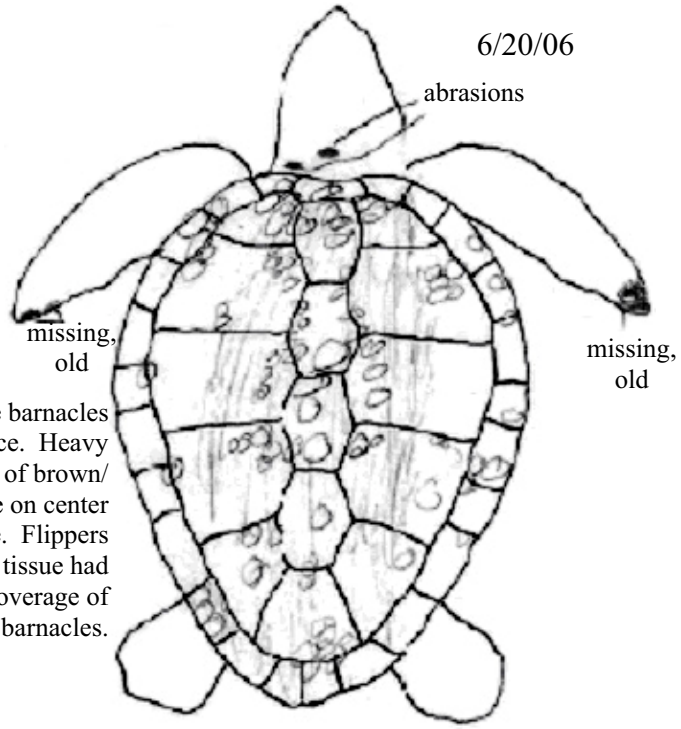
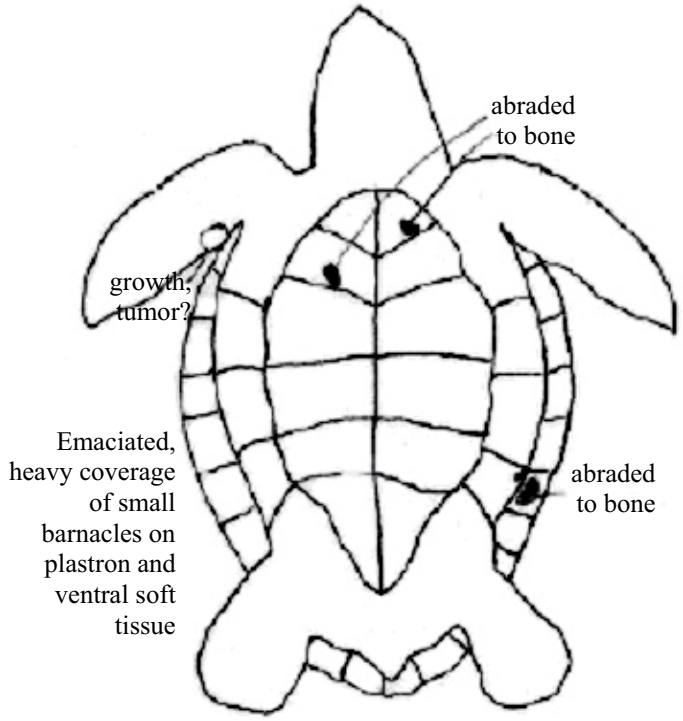
Turtle #3 Post-test documentation 6/20/06
Tow #8

Some barnacles (~5-10%) knocked off center carapace

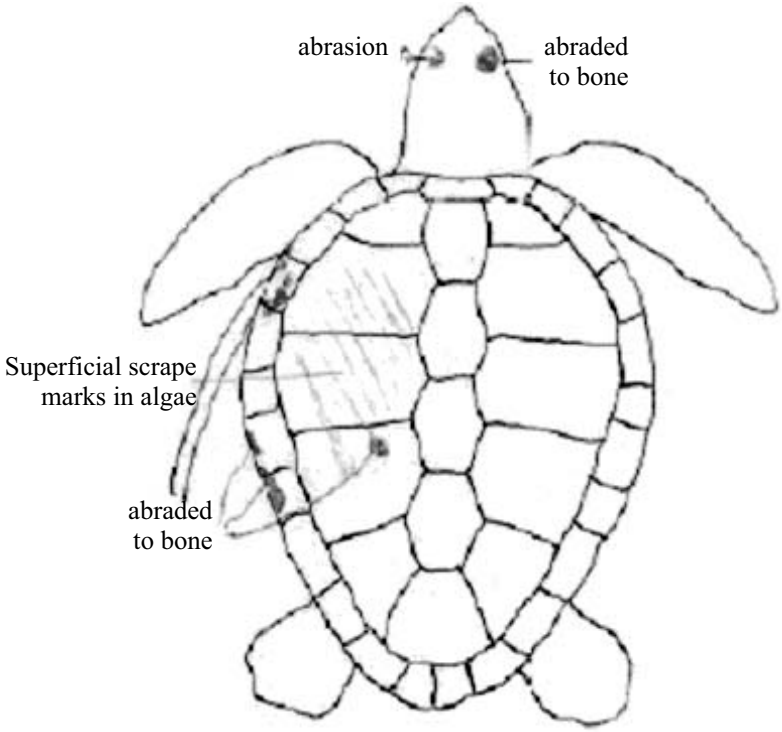
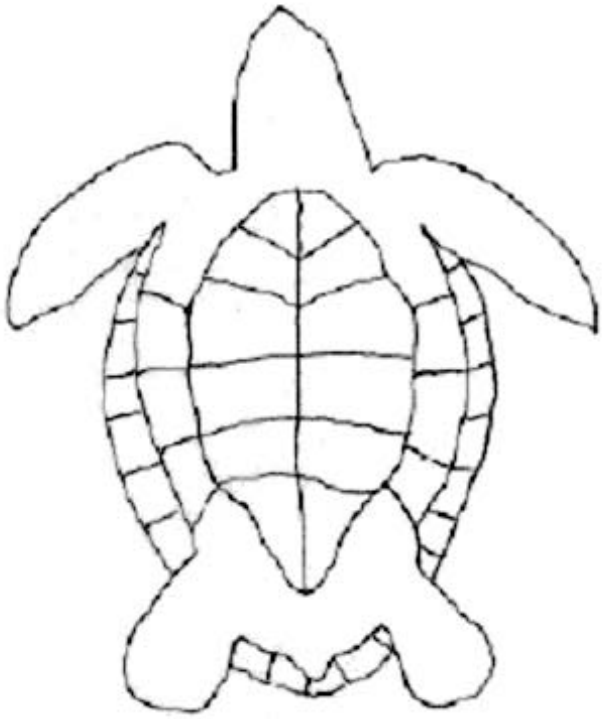
No additional ventral injuries seen

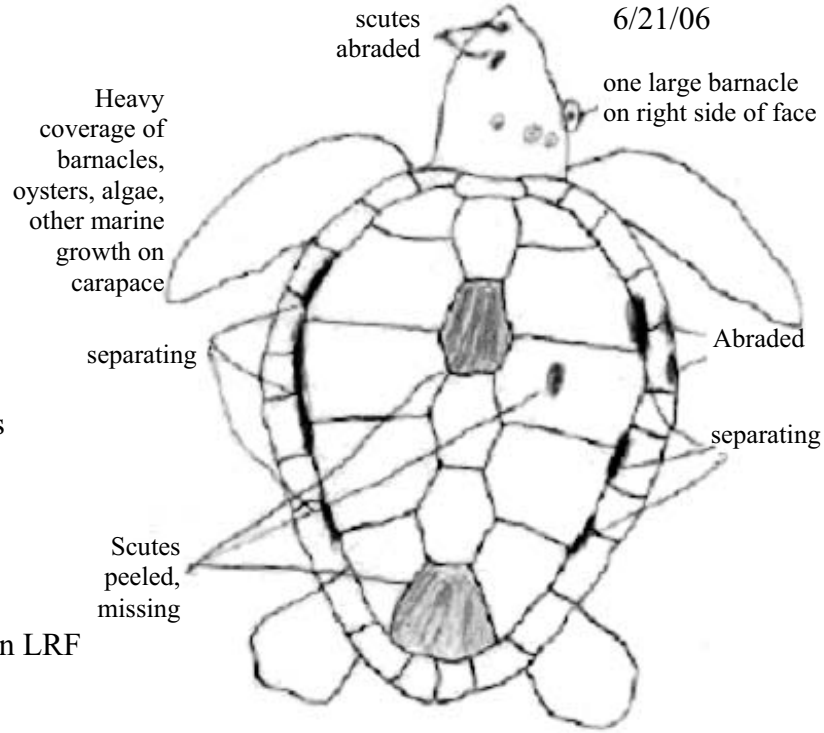
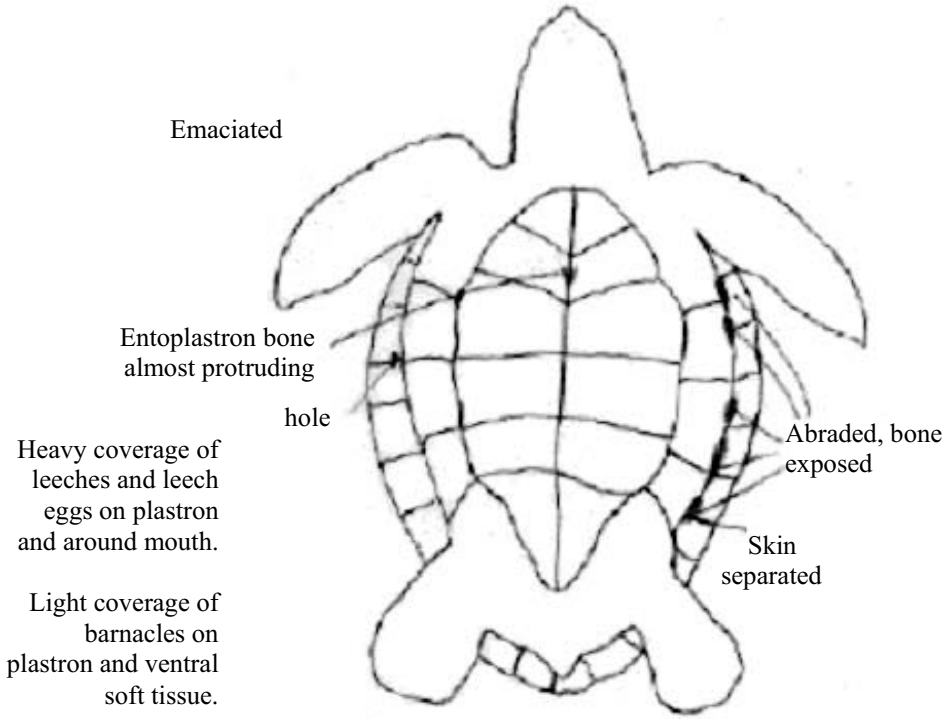
Turtle #4 Post-test documentation 6/21/06

Separation/hole larger between L marginals and LC #2. Hole between R marginals. RC #2 scute gone/abraded on R posterior marginal and minor on R side marginals. Bone exposed (skin abraded) on posterior carapace where scute was missing previously.

Tow #12 – no additional damage
Tow #13 – carapace bone broken. RC#3 and adjacent marginals; crack in posterior carapace.

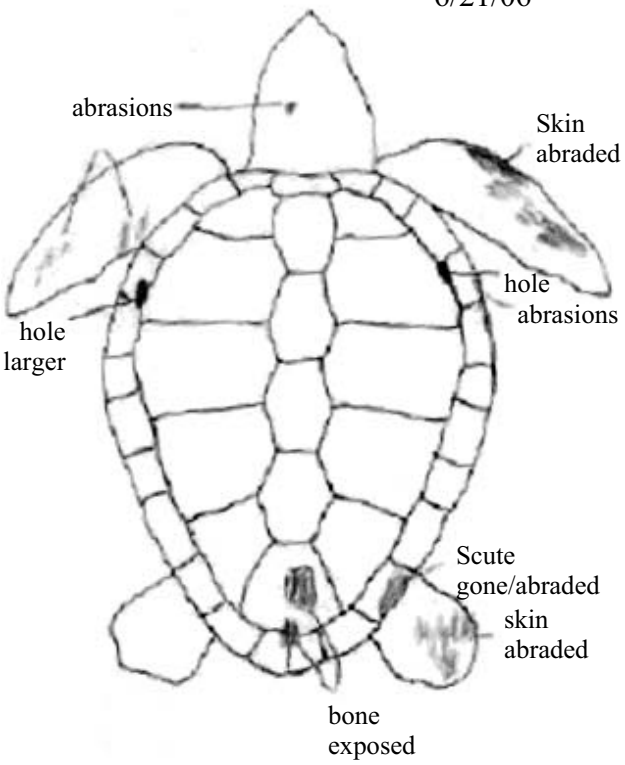
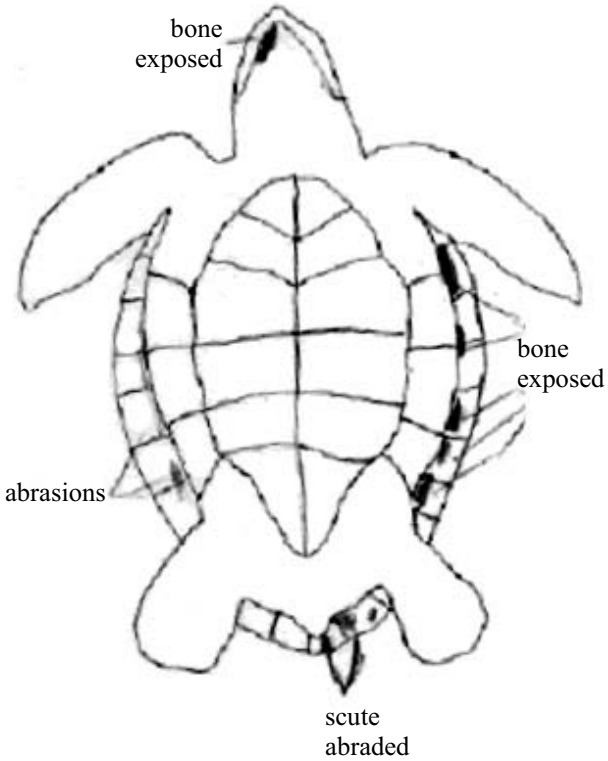
Scutes abraded from dorsal surfaces of both front flippers and R rear flipper.

Bone exposed on right side of jaw bone.

Bone exposed along left side of plastron where marginals meet plastron – more abraded and over larger area than pre-test documentation.

Scutes abraded on ventral posterior marginals.

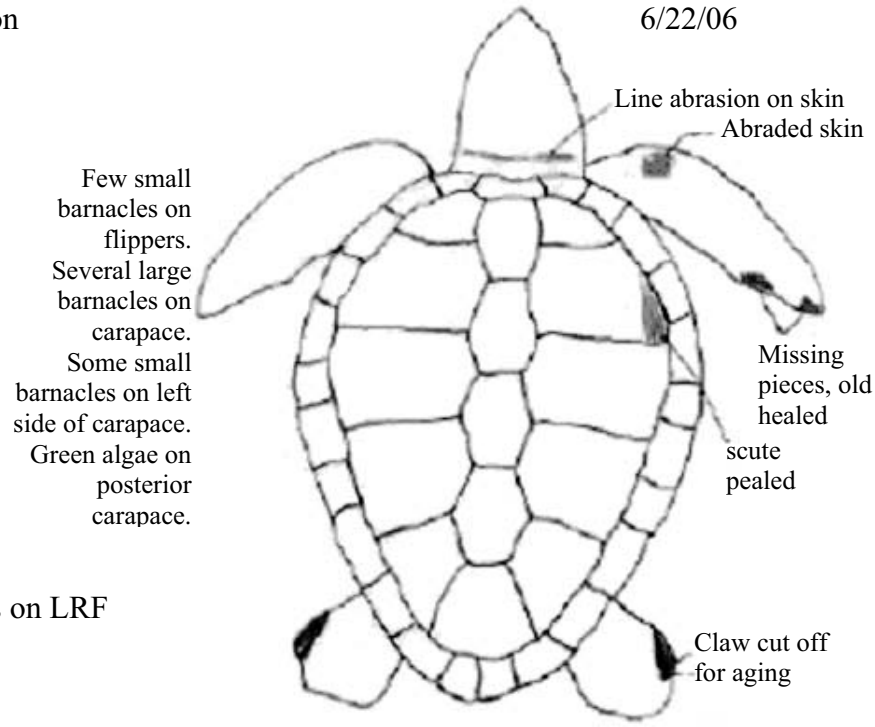
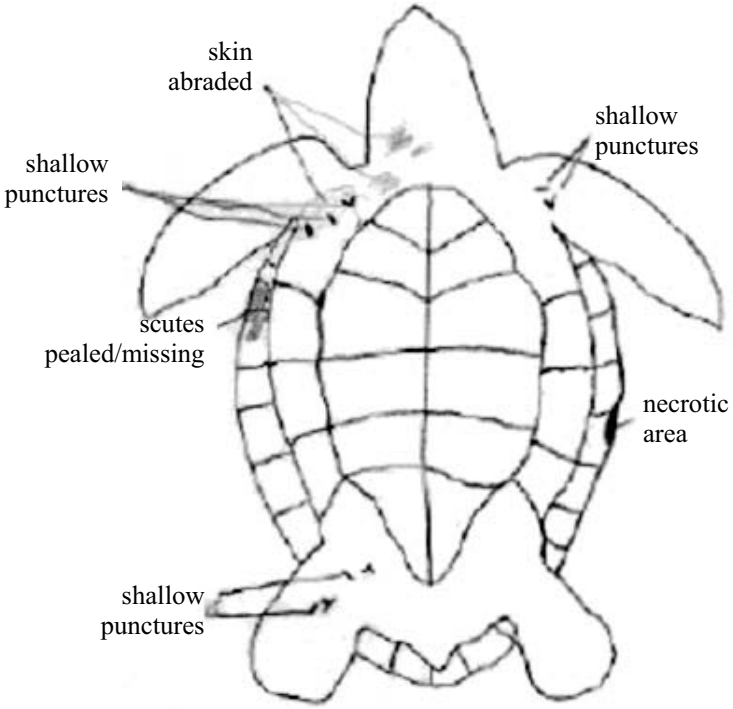
Turtle #5  Post-test documentation 6/22/06

No additional damage seen relative to pre-test documentation.

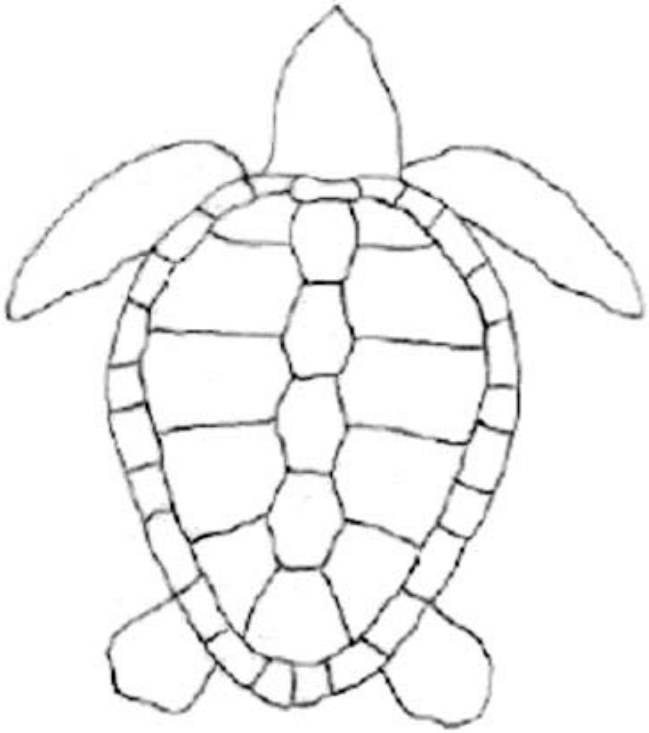
Carcass examined from a small boat while carcass still in water.
